# **Table of Contents**

Generally, a LRTP describes a strategy and capital improvement program developed to guide the effective investment of federal Tribal Transportation Program (TTP) funds in multimodal transportation facilities. Each tribe reviews and updates its LRTP every five years (25 CFR §170.414) in an effort to ensure the plan reflects any changes in projected funding, major improvement studies, or tribal goals, vision, and mission for its transportation facilities, projects, corridor justification studies, and environmental impact studies. The LRTP provides the foundation on which a Tribe develops its short-range Tribal Transportation Improvement Plan (TTIP). A Tribe must complete the LRTP and the TTIP before it can spend TTP funds.

Seneca Nation, a federally recognized Native American Tribe, functions as an autonomous and sovereign nation with a total enrolled population of 8,498 persons. Its land base consists of five non-contiguous territories geographically surrounded by western New York—shown in **Figure 1**—representing over 84 square miles.

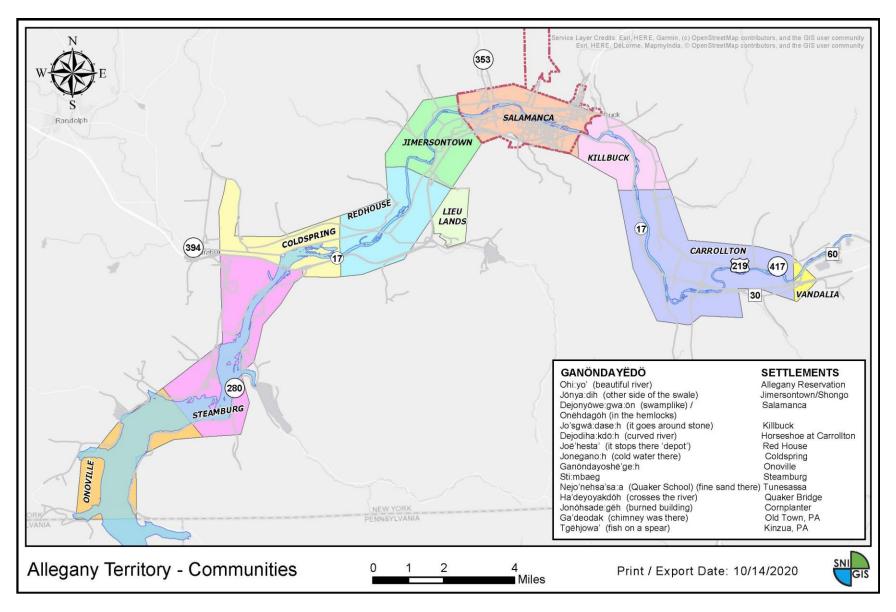
Figure 2: Communities within Allegany Territory

The largest territories are subdivided into smaller community areas, as shown in **Figure 2** and **Figure 3** on the next pages.

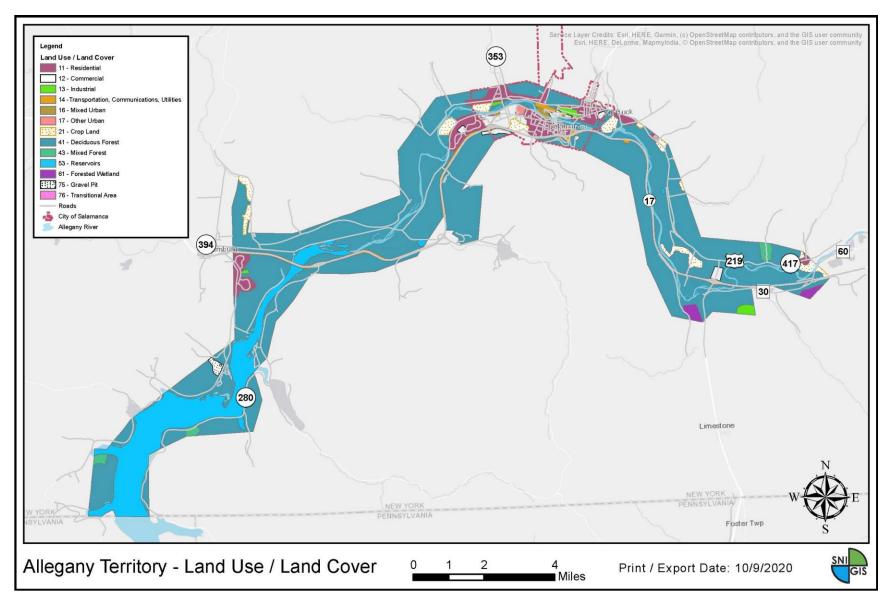
Figure 8: Allegany Territory Land Use

Furthest south, the Allegany Territory (**Figure 8**) covers 48.7 square miles along the Allegheny River or the Ohi:yo' River (Beautiful River), its southern tip abutting the Pennsylvania border. It is located between major tourism destinations: Ellicottville's Holiday Valley and Holi Mont, Allegany State Park, Allegheny National Forest, and the Allegheny Reservoir.

The territory is primarily a rural setting, with medium development densities in the City of Salamanca. Most of the developed land is used for residential and commercial purposes. Residentially, single family homes are the rule for housing—found throughout the territory with concentrations located in Kill Buck, Jimersontown, and Steamburg. Other residential lands can be found in lesser concentrated areas mainly on the east side of the territory in the communities of Carrollton, Vandalia, and South Vandalia.

Industrial, commercial, and governmental facilities are found at some of more densely developed areas near Salamanca. Route 417 forms the main transportation spine through the community, connecting to the STE at exit 20 and continuing eastward to St. Bonaventure University and eventually I-99. Commercial establishments include restaurants, retail outlets, offices, and some industrial/manufacturing uses. The largest employers on territory are the Nation's government, the Seneca Allegany Casino and Resorts, Luminite Products Corporation, and Conrail.

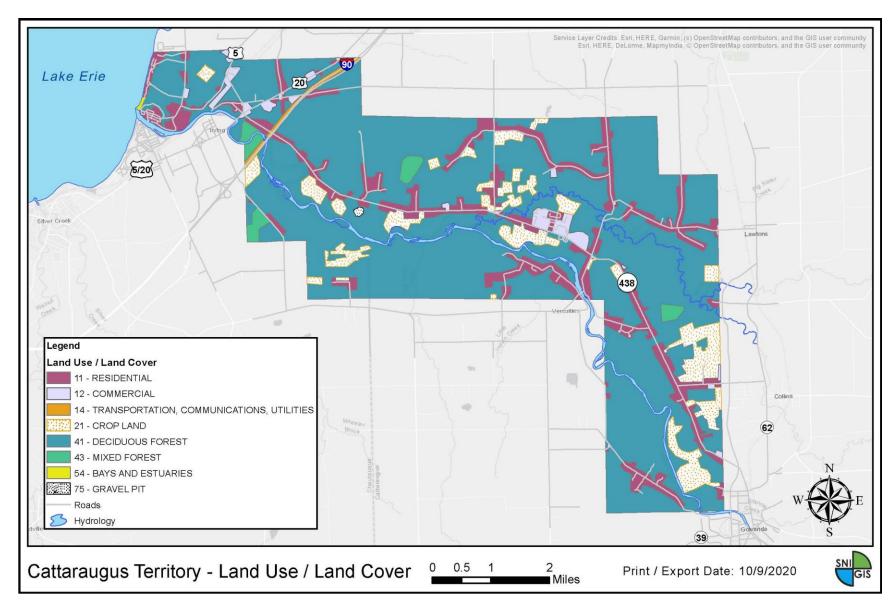
Figure 9: Cattaraugus Territory Land Use

The Cattaraugus Territory (**Figure 9**, page 20) is the other primary residential territory, including 34.4 square miles along Route 438 and Cattaraugus Creek between the cities of Irving and Gowanda. Major transportation corridors including I-90 (NY State Thruway) and US Routes 5 & 20 run through its western edge.

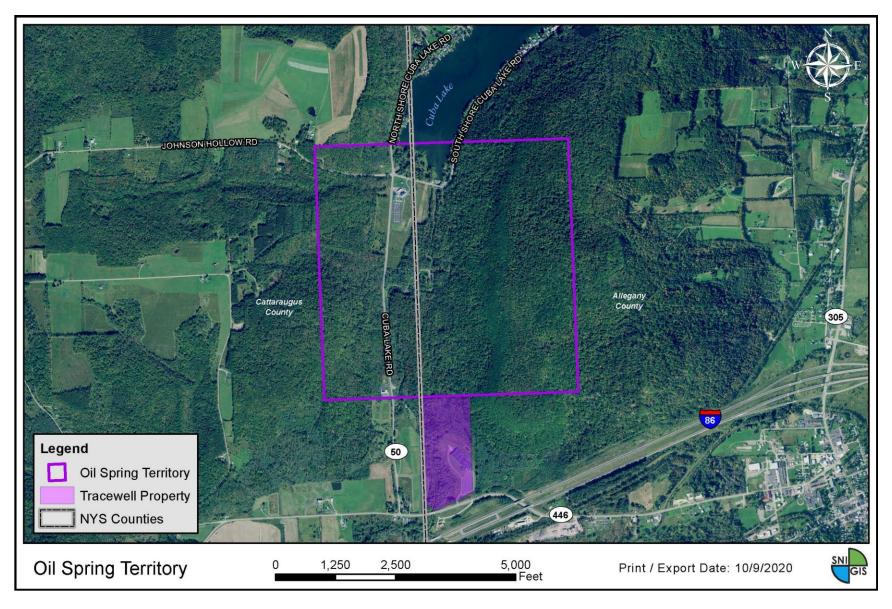
Figure 10: Oil Spring Territory Map

This territory covers one square mile along the spillway end of Cuba Lake (**Figure 10**, next page), site of the famed spring described by the Franciscan Missionary Joseph De La Roch D'Allion in 1627, the first recorded mention of oil on the continent. Senecas were known to have used the oils of the area for medicinal purposes. Although there is only one Seneca resident on the property, there are both Seneca and privately owned enterprises operating there. A Seneca One-Stop convenient store and gas station operates adjacent to a Class II gaming facility that opened in 2014. The gaming facility and One-Stop draw business from tourists that visit the lake as well as from the STE that passes the Territory a short distance to the south. The Nation also recently acquired the former Tracewell Building and property - a state of the art manufacturing facility.

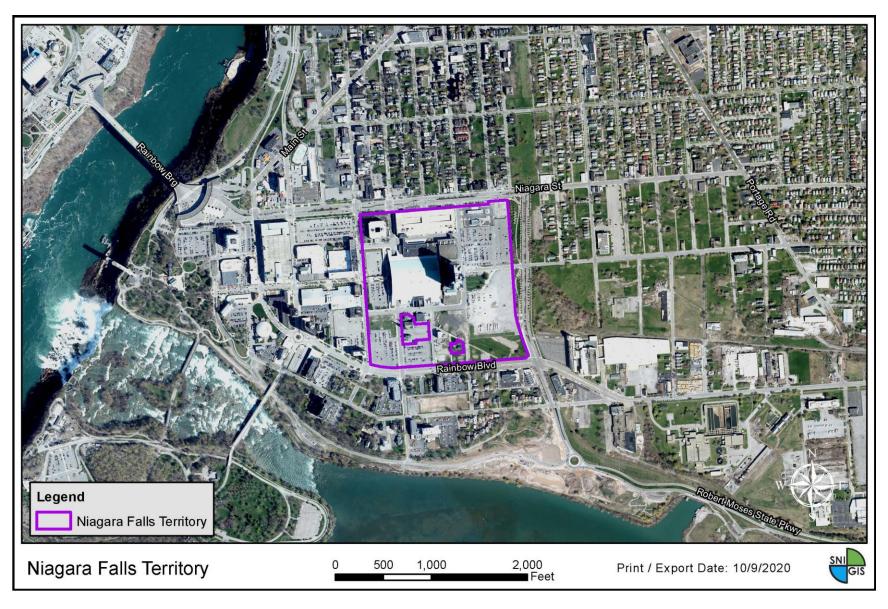
Figure 11: Niagara Falls Territory Map

Site of the city's former convention center, the Niagara Falls Territory (**Figure 11**, page 23) was acquired in 2001 and converted into a class III gaming operation. The property is bounded by Niagara Street, 3rd Street, Rainbow Boulevard and John B. Daly Boulevard. The Territory is conveniently located two blocks from the Robert Moses Parkway, one of the major routes in and out of the city, and within three blocks of the famed American Falls, which attracts an estimated 3 million visitors annually.

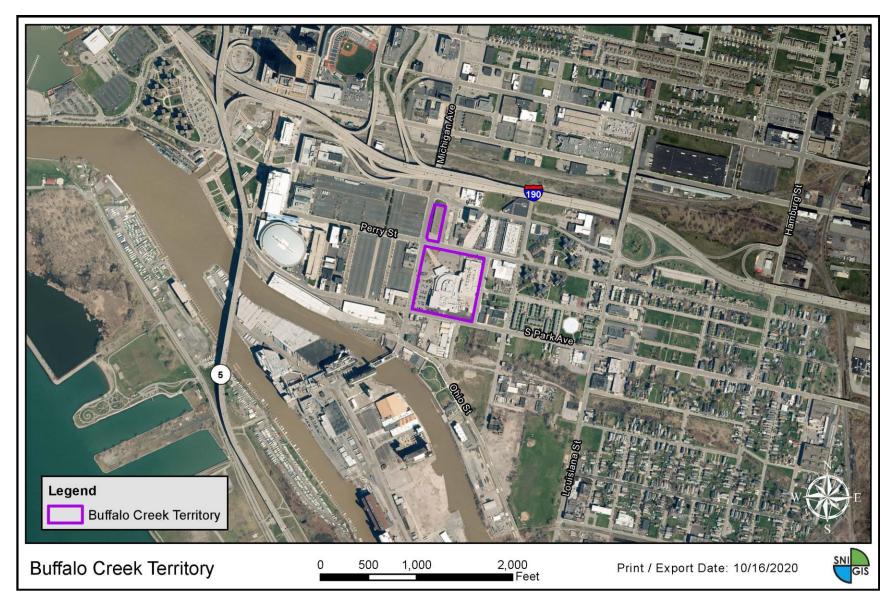
Figure 13: Buffalo Creek Territory Map

Buffalo Creek (**Figure 13**, page 25) was acquired in 2005 with the full-service Buffalo Creek Casino constructed in 2010. Bounded by Perry Street, Michigan Avenue, South Park Avenue, and Mervin Street, the property is within a quarter mile of the newly revitalized Canalside development along Buffalo's waterfront and Key Bank Arena, home of the Buffalo Sabres professional hockey team and the Buffalo Bandits professional NLL lacrosse team.

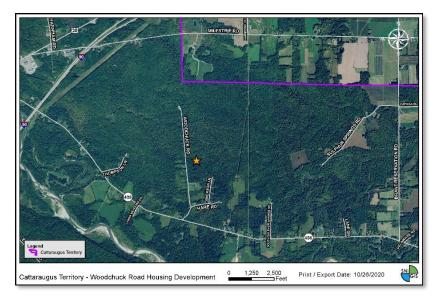
#### PROPOSED WOODCHUCK ROAD DEVELOPMENT

Conversations with various Nation departments during October 2020 suggested most short-term land use changes represent additional housing. Small clusters of single-family homes are planned/permitted throughout the Cattaraugus Territory: along Woodchuck Road, Farnham Road/Railroad Avenue, Young Road, Bush Road, and Ozark Meadows Road. A 40-unit Seneca Housing subdivision on 60 acres between Woodchuck Road and Milestrip Road is a potential project being considered. The area

has utility infrastructure but will likely require extension of Woodchuck Road to improve accessibility.

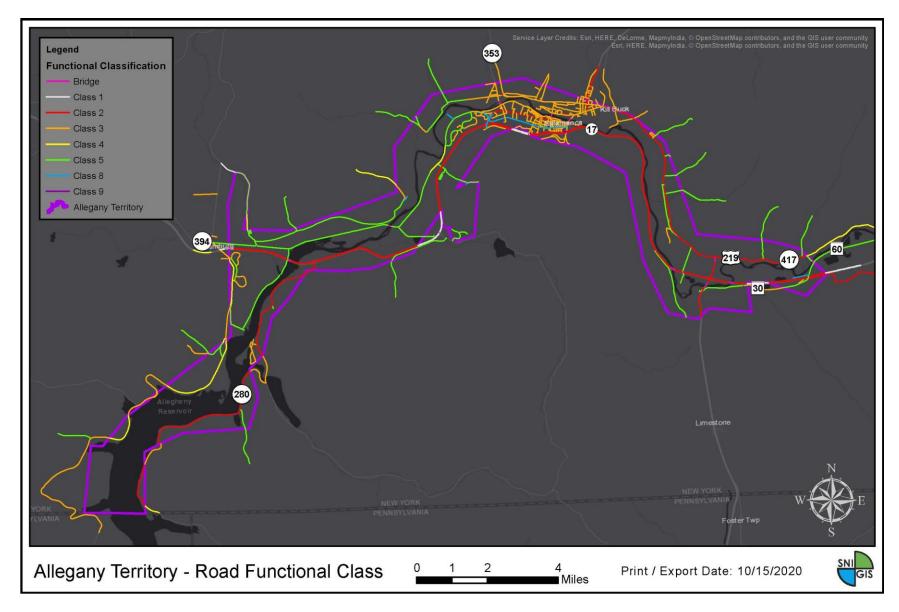
Figure 14: Functional Classification of Highways, Allegany

Shown in **Figure 14**, the Allegany Territory is easily accessible by expressway and county routes. The Allegany Territory has a portion of the STE traversing it east-west and carrying up to 11,300 vehicles per day (vpd) through the property. STE runs west to Erie, PA and east to just outside New York City, passing near the Oil Spring Territory as well.

**Figure 22** presents a visual comparison of BIA classes between the two main territories; **Figure 14** and **Figure 15** above provide maps of functional classifications for both main territories.

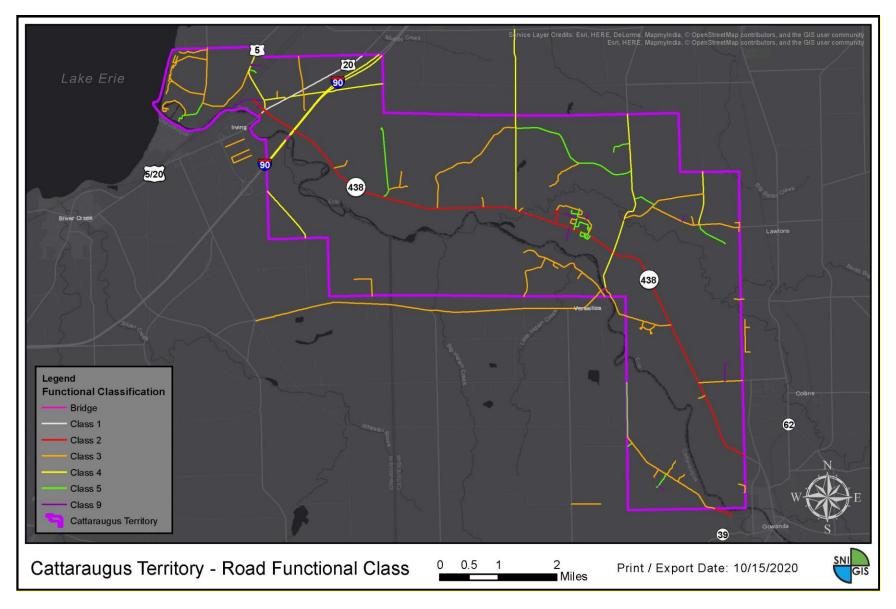
Figure 15: Functional Classification of Highways, Cattaraugus

Shown in **Figure 15** (page 33), the Cattaraugus Territory is easily accessible by interstate and county routes, with a portion of the NY State Thruway passing through it, intersecting the western edge of Cattaraugus Territory in a northeast-southwest direction and carrying 27,000 vpd in the vicinity. US 20 and Route 5 also provide principal arterial access in the vicinity, each carrying about 6,700 vpd. Each provides easy access to the city of Buffalo, which is only 40 minutes from the Cattaraugus Territory. Route 5 is the more scenic route and is also known as part of the Great Lakes Seaway Trail, a national scenic byway.

Route 438 is a major collector route, running northwest-southeast through the territory and carrying 2,900-5,700 vpd. It links I-90 to Gowanda and provides access to properties throughout the Cattaraugus Territory.

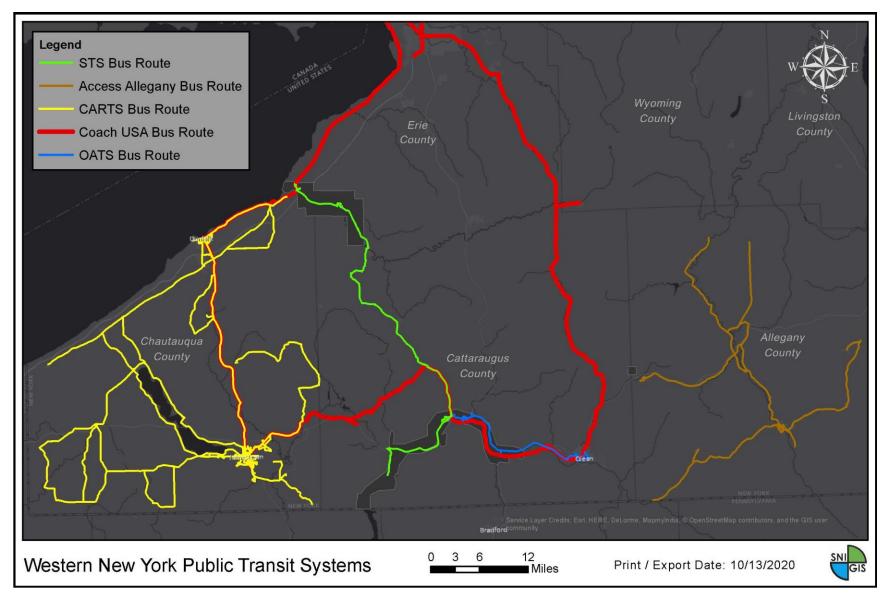
Figure 16: Regional Transit Routes

A host of transit agencies provide regional connections throughout the region; **Figure 16** illustrates regional transit routes and connections near the two largest territories.

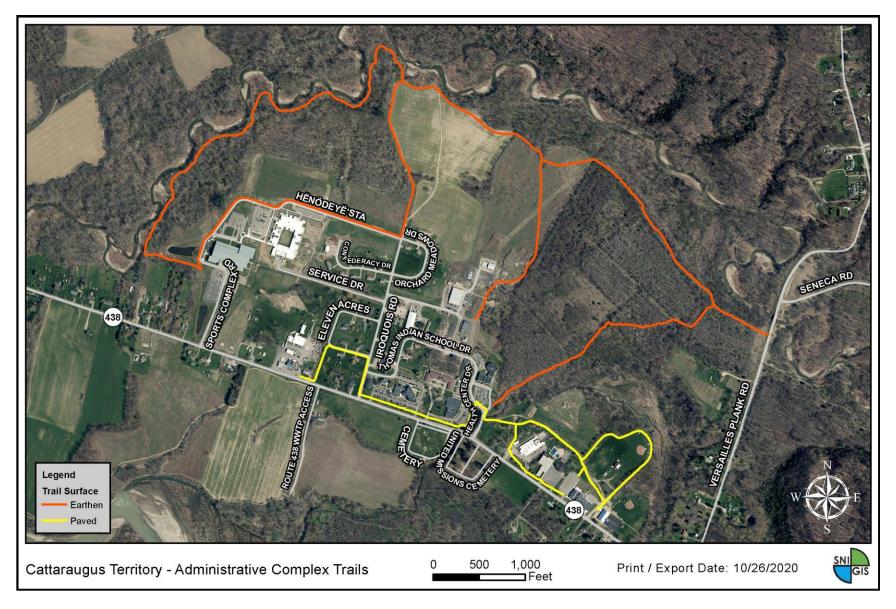
Figure 18: Cattaraugus Territory Trails

Within Cattaraugus Territory, a walking path/bike trail connects between the Wolf's Run convenience center and American Legion. An informal primitive trail connection also stretches between the administrative complex, sports fields, Clear Creek, and Versailles Plank Road. Both are shown in Figure 18 (page 39). Near the eastern boundary of the territory, sections of the regional Shoreline Trail are under construction, creating a link along Lake Erie and the Niagara River from Chautauqua County to Grand Island.

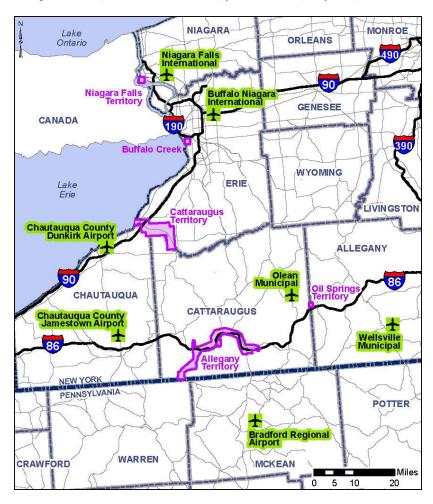
Figure 19: Regional Airports

Southwestern New York State is serviced by four general aviation airports (**Figure 19**). These include Chautauqua County Airfield in Jamestown, Chautauqua County Airfield in Dunkirk, Olean Municipal Airport, and Wellsville Municipal Airport. The Jamestown Airport also offers limited commercial passenger service. Each of these airports boasts state-of-the-art navigation

systems and all have paved runways of varying length. Specific services offered at each airport vary, but can include fuel, hangar rental, commuter service, plane rental, repairs, etc.

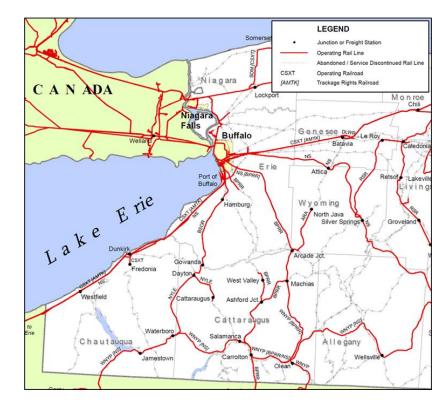
Figure 20: Regional Rail Infrastructure, per NYSDOT 2019

Shown in **Figure 20**, railroad infrastructure is also entrenched in the region, running through both the Cattaraugus and Allegany Territories. Two Class I Railroads—Norfolk-Southern and CSX—operate in the region. As well, there are three Class III short-line operators that service the region. The Port of Buffalo is a large intermodal port on Lake Erie, a major factor in the region's freight economy.

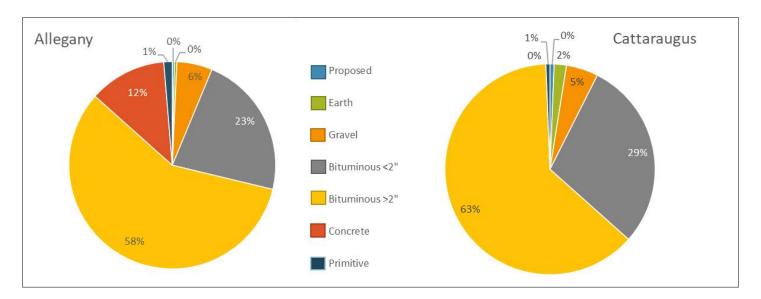
Figure 23: Breakdown of Surface Type by Territory

With varying maintenance requirements, roadway surface types are tracked as part of the system inventory. By mileage, over 80% of Nation inventory routes are paved with bituminous pavement (Figure 23, page 47). The Allegany Territory also includes 18.3 miles of roadway with concrete pavement. Widths are generally adequate for modern traffic: 16.3 miles of roadways in Allegany Territory and 5.5 miles in Cattaraugus Territory provide surface widths less than 18 feet. About 1% of the system is unclassified in the inventory—that is, other agencies track/maintain this item.

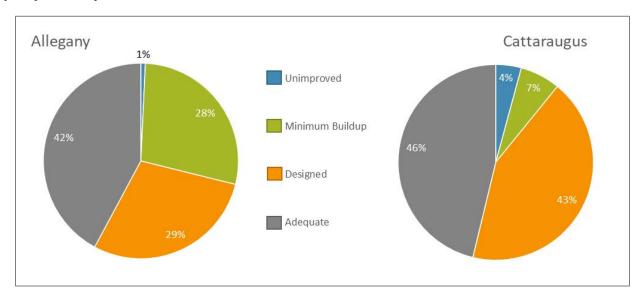
Figure 24: Breakdown of Roadbed Condition by Territory

**Roadbed condition** is classified into one of four categories: unimproved (poor drainage/alignment), minimum buildup (inadequate drainage/alignment), designed (some drainage/alignment issues), or adequate. Shown in **Figure 24** (page 47), 22% of the system mileage falls into lower categories that may benefit from additional engineering. About 2% of the system is unclassified.

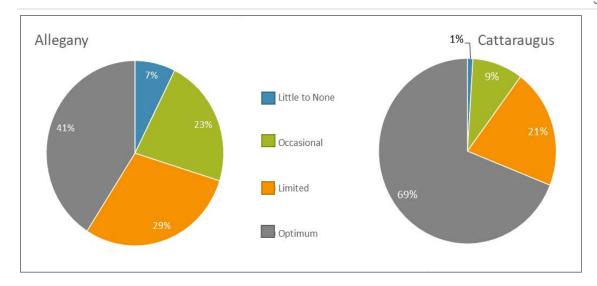
Figure 25: Breakdown of Maintenance Level by Territory

Figure 25 (page 48), 25% of the system mileage falls into lower categories that may benefit from additional maintenance; however, a relatively large portion of the system is unclassified in the inventory—indicating another entity is responsible for maintenance activities, tracked via different management systems. This mileage is omitted from the chart.

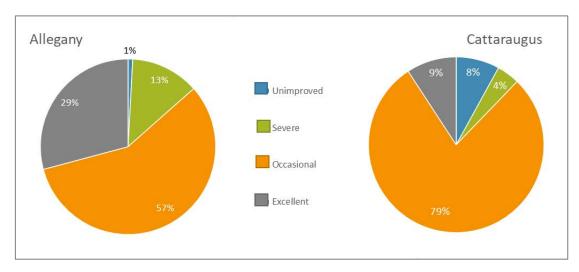
Figure 26: Breakdown of Drainage Condition by Territory

**Drainage condition** is rated into one of four categories: unimproved routes, severe problems, occasional problems for short periods during or following normal storms, or excellent. Shown in **Figure 26**, nearly half of the system mileage falls into lower categories that may benefit from additional drainage; however, nearly 40% of the system is unclassified in the inventory.

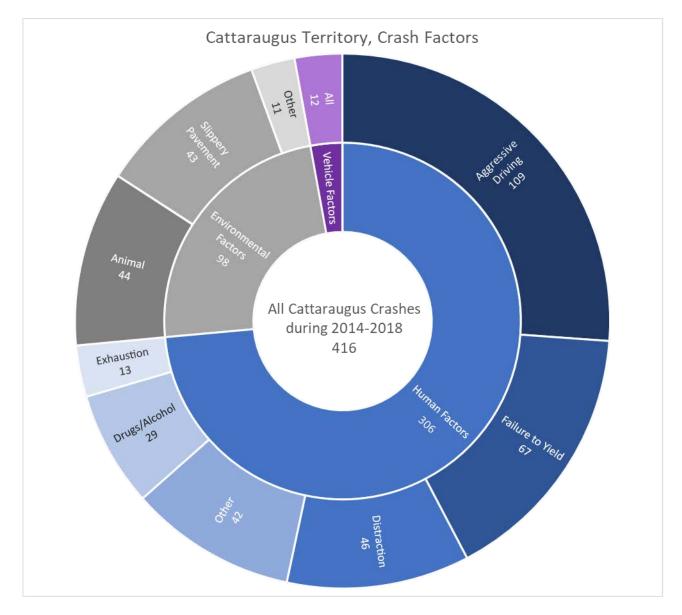
Figure 27: 2014-2018 ITSMR Crash Factors, Cattaraugus Territory

ITSMR data for crashes during 2014-2018 on the two primary Nation territories highlights causation factors influencing crash patterns. Shown graphically in **Figure 27** (page 51) and **Figure 28** (page 52), human factors (e.g., aggressive driving) are the leading cause while environmental factors like animal collisions and slippery pavement also represent a significant distribution.

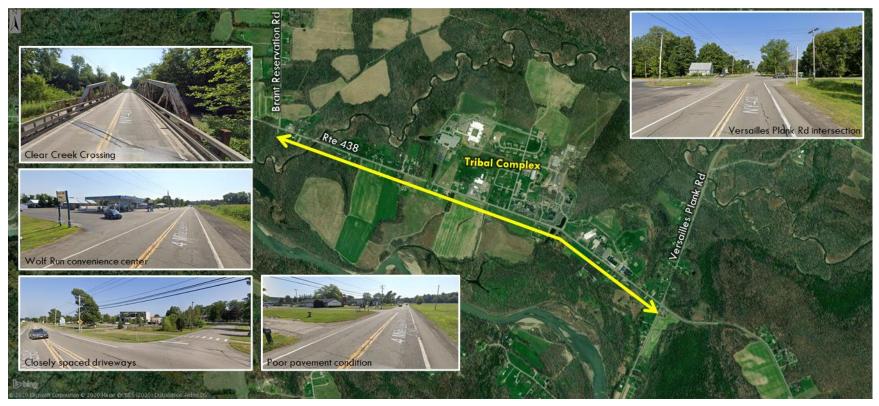
Figure 29: Route 438 Safety Corridor

▼ Route 438 Corridor Safety Improvements, Cattaraugus Territory. The section of 4 Mile Level Road near the administrative complex—from Versailles Plank Road to Brant Reservation Road, about 1.8 miles in length—was recommended

for a Corridor Safety Plan. During 2014-2018, 32 crashes were reported, including one fatality and 59% resulting in injuries. Shown in **Figure 29**, narrow lanes/shoulders, numerous driveways, and unlighted stretches are noted as potentially contributing factors. The intersection with Versailles Plank Road is called out as a separate improvement, discussed below. The \$10.6 million reconstruction includes three 12-foot lanes, 8-foot shoulders, drainage, clear zones, lighting, a preemptive signal at the fire station, transit stops, and traffic calming measures.

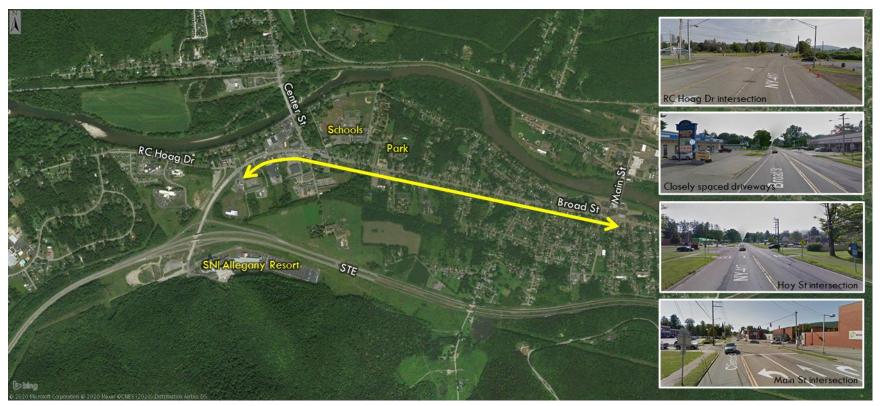
Figure 30: Route 417 Safety Corridor, Salamanca

Route 417/Broad Street Corridor Safety Improvements, Allegany Territory. The section of Broad Street through Salamanca—from Main Street to RC Hoag Drive, about 1.7 miles in length—contained 89 crashes during 2014-2018, including 15% injury collisions. Poor pavement condition/striping and numerous driveways are cited as contributing factors. The corridor is highlighted in Figure 30. Within this section, two intersections are proposed for reconstruction as a roundabout

The proposed \$12.6 million reconstruction provides three 12-foot lanes, curb/gutter, lighting, 5-foot bike lanes on both sides for a portion of the route, and replacement signals at Center Street. Beyond the NYSDOT project, extension of the multi-use trail from RC Hoag Drive to McDonalds, crosswalk improvements, and driveway consolidation are also recommended.

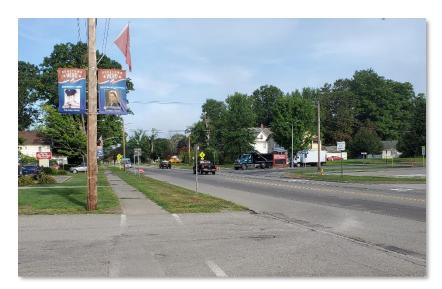
Broad St/Hoy St Intersection

Engineering designs are under development to reconstruct the Broad Street, Iroquois Drive, Hoy Street, and Messenger Street intersection as a roundabout. Current challenges contributing to high crash rates include poor pavement condition, wide lanes with poorly delineated striping, closely spaced driveways, and lengthy queues waiting to access the adjacent Tim Hortons restaurant that back into the highway. There were 20 crashes at the intersection during 2014-2018.

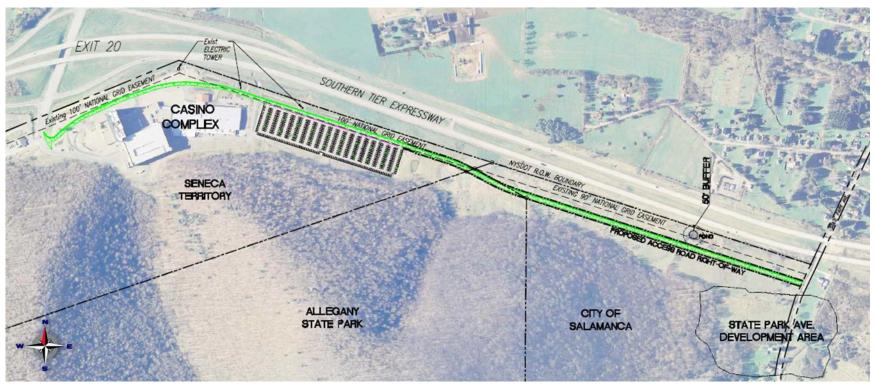
Figure 31: Option 1 for Seneca Allegany Boulevard Extension from 2008 Study

In 2011, the city completed a feasibility study to extend the casino frontage road eastward to meet State Park Avenue. The connection is complicated by high volume traffic needs of the adjacent casino resort, steep terrain to the south, a large National Grid utility easement parallel to the interstate, and the state park. Earlier efforts to create a new STE interchange were not successful.

The least expensive configuration studied (**Figure 31**) would reconstruct the Seneca Allegany Boulevard with two 14-foot lanes, an 8-foot sidewalk, and 7-foot offset; other options considered use of the STE right-of-way and/or relocation of the National Grid Easement. In 2006 dollars, estimated costs ranged from \$4.6 to \$13.1 million.

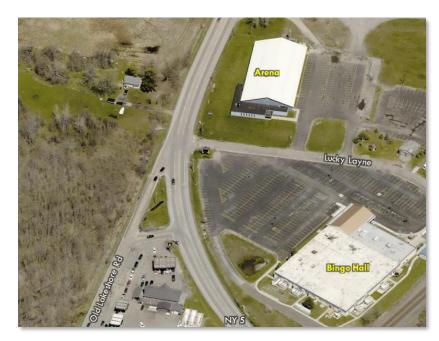
ROUTE 5/LUCKY LAYNE/OLD LAKESHORE ROAD, NEAR IRVING

Today, Route 5 (Erie Road) provides a three-lane connection along Lake Erie; Old Lakeshore Road and Lucky Lane form a wide offset intersection in a horizontal curve. Providing access to a class II gaming facility, sports arena, and convenience store, each approach serves relatively high traffic volumes. Further, a potential STS transit hub in an adjacent field would increase traffic demands using this high-crash location. Reconstruction of the intersection is recommended.

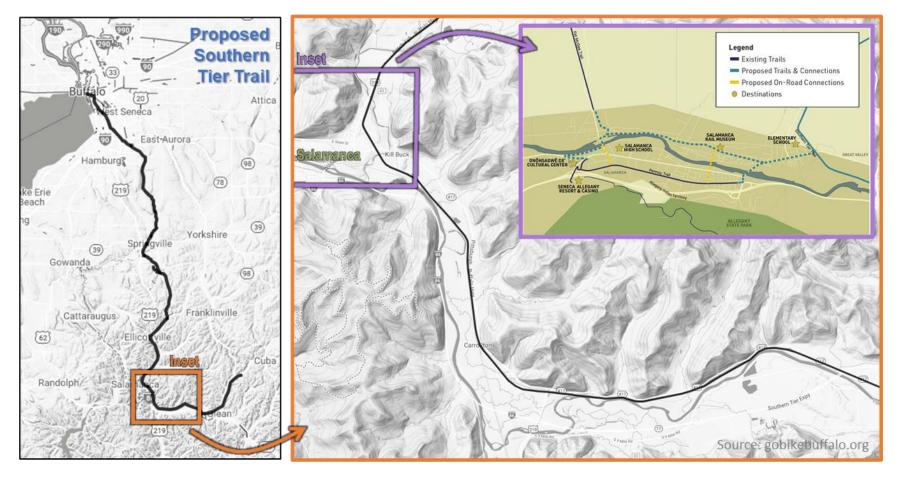
Figure 34: Southern Tier Trail Concept with Allegany Territory (orange) and Salamanca (purple) Insets

Regionally, **GObike Buffalo** is studying the feasibility of creating a Southern Tier Trail multi-use path (**Figure 34**, page 71) from Buffalo to Hinsdale, covering 80 miles with connections to 20 towns, the 750-mile Empire State Trail, 580-mile Finger Lakes Trail, and the 90-mile Genesee Valley Greenway. The inset orange box (right) shows the proposed trail location through the Allegany Territory.

GObike was also invited to tour the recently completed Pennsy Trail through Salamanca, making recommendations to bolster Salamanca as a "Trail Town" destination within the region. Recommendations include additional connections (inset purple box in **Figure 34**), street crossing enhancements, trail improvements (i.e., vegetation and amenities), wayfinding signage, and maintenance/operational strategies.

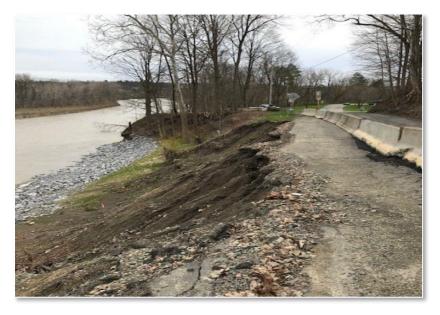
PROSPECT STREET LANDSLIDE

Prospect Street Landslide Repairs, Off Cattaraugus Territory. Efforts continue to secure funding to repair landslide damage along Prospect Street/Indian Hill Road.
